Final Technical Report
on
**FUNDAMENTAL STUDIES ON THE CORROSION BEHAVIOR OF
WELDMENTS IN MARINE MICROBIAL ENVIRONMENTS**

1. AGENCY USE ONLY (Leave blank)		2. REPORT DATE April 1996	3. REPORT TYPE AND DATES COVERED Final 9/30/92 to 1/31/96	
4. TITLE AND SUBTITLE OF REPORT Fundamental Studies on the Corrosion Behavior of Weldments in Marine Microbial Environments			5. FUNDING NUMBERS N00014-92-J-4116

Final Technical Report

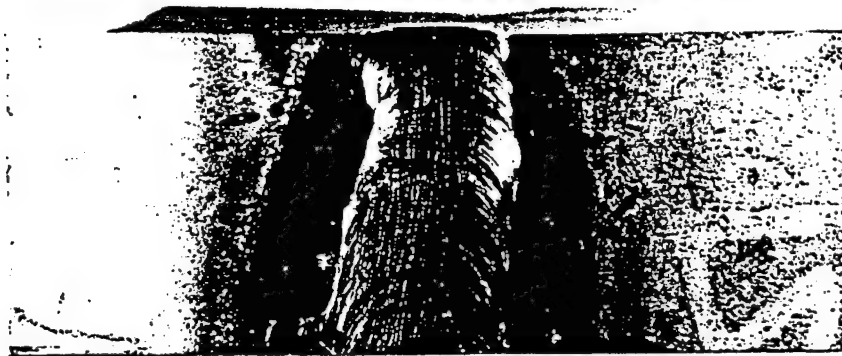
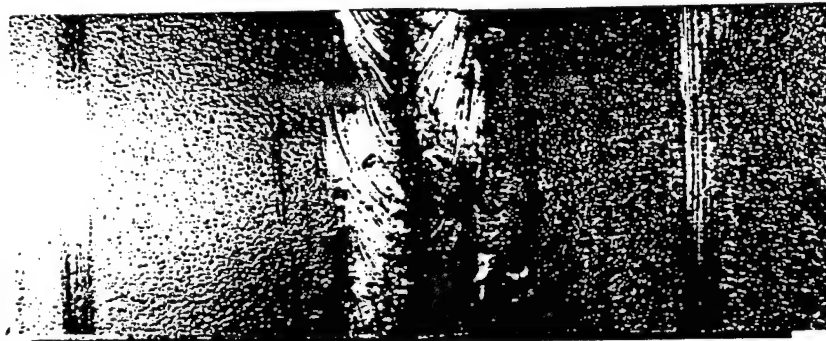
Figure 7. Surface conditions for weldment #1 (304L/308L) : (a) #1-a, ID surface, no treatment (b) #1-a, OD surface, no treatment (c) #1-b, ID surface, brushed (d) #1-b, OD surface, brushed.
